# Bayfront Tower

## Background on Bayfront Tower's Structural Findings by Slider Engineering

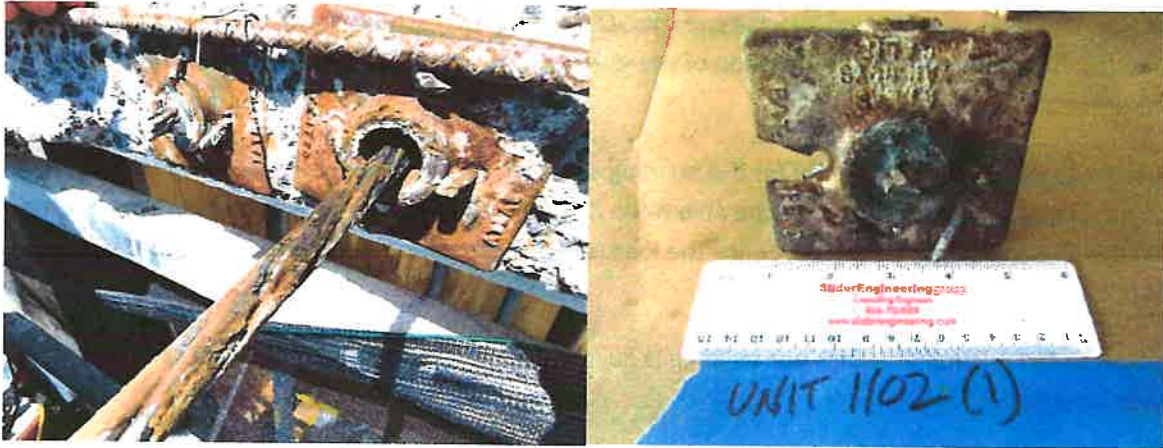
Unfortunately, the inspections performed by our engineers show that there is corrosion on both the anchors and the cables themselves. There are thousands of PT cables and associated anchors in our building embedded in concrete, so the costs associated with repairs can climb rapidly.

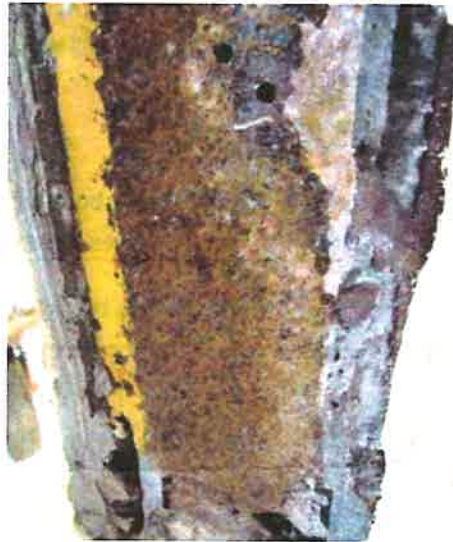
is a porous substance, moisture can permeate through the stucco and corrode the metal framing components designed to hold the stucco in place. This is exactly what has happened around our building and the corrosion had progressed to a point of failure in some locations as early as 2001. This problem was not unique to Bayfront Tower as a number of other buildings were constructed in a similar fashion and suffered the same fate. A common solution at that time was to open up the walls where corroded framing was expected and then “sister” new metal framing components to the deteriorated existing framing. To complete the process a siliconized paint would then be applied to keep the moisture out. Unfortunately, this solution commonly failed and only bought some time before the stucco and metal framing had to be removed and a proper system put in place.

We are now at the point where the stucco system must be replaced. Replacement includes removing the windows and sliding doors in all of the units and replacing the corroded framing components as well as repairing any damaged CMU block that is found before applying a proper stucco system with a true vapor barrier. This is a messy process but one that is necessary to give our windows and doors the proper framing to be secure and to prevent water from leaking into the building. Unfortunately, both old and new windows must be removed to provide the correct protection we need.
