# Bayfront Tower

## Background on Bayfront Tower's Structural Findings by Slider Engineering

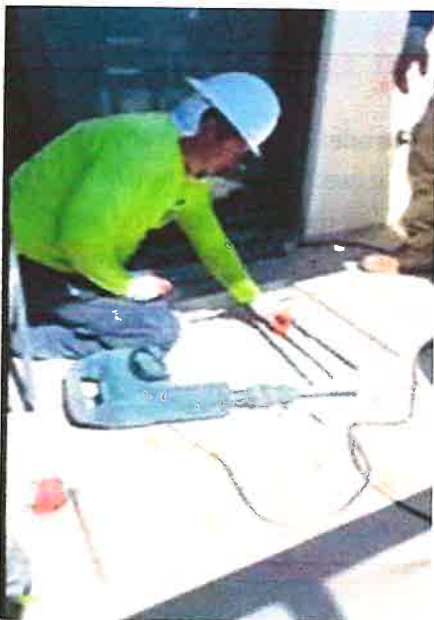
Unfortunately, the inspections performed by our engineers show that there is corrosion on both the anchors and the cables themselves. There are thousands of PT cables and associated anchors in our building embedded in concrete, so the costs associated with repairs can climb rapidly.

This process of testing will reveal if: 1) the whole cable and anchor must be replaced; or 2) only the anchor requires replacement; or 3) the existing components can be just cleaned, coated with rust retardant materials and left in service. Each outcome has a specific cost associated with it, and in some cases the repairs required could necessitate cutting into the slab to access the cable to be repaired correctly.

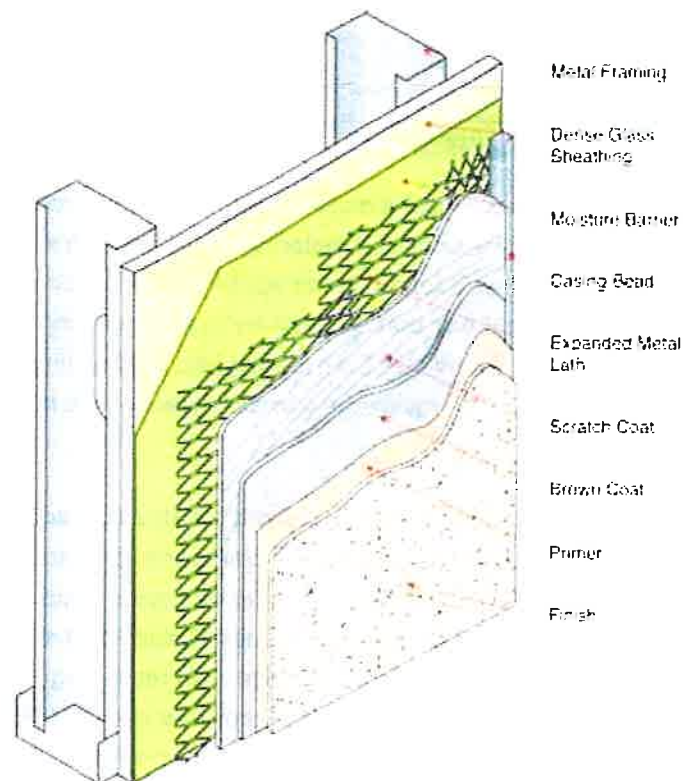
The above image gives a good representation of a typical metal framed stucco system. Each part of this system has a specific purpose and the one key element that is missing from our building is the moisture barrier. Areas of our building exterior were constructed without a moisture barrier and because stucco

is a porous substance, moisture can permeate through the stucco and corrode the metal framing components designed to hold the stucco in place. This is exactly what has happened around our building and the corrosion had progressed to a point of failure in some locations as early as 2001. This problem was not unique to Bayfront Tower as a number of other buildings were constructed in a similar fashion and suffered the same fate. A common solution at that time was to open up the walls where corroded framing was expected and then “sister” new metal framing components to the deteriorated existing framing. To complete the process a siliconized paint would then be applied to keep the moisture out. Unfortunately, this solution commonly failed and only bought some time before the stucco and metal framing had to be removed and a proper system put in place.

We are now at the point where the stucco system must be replaced. Replacement includes removing the windows and sliding doors in all of the units and replacing the corroded framing components as well as repairing any damaged CMU block that is found before applying a proper stucco system with a true vapor barrier. This is a messy process but one that is necessary to give our windows and doors the proper framing to be secure and to prevent water from leaking into the building. Unfortunately, both old and new windows must be removed to provide the correct protection we need.
